Blade Supplemental Report (Vol. 4: Aliso Canyon Casing Integrity) I.19-06-016

Root Cause Analysis of the Uncontrolled Hydrocarbon Release from Aliso Canyon SS-25

Volume 4: Aliso Canyon Casing Integrity

Analysis of Aliso Canyon Gas Storage Wells with Casing Failures

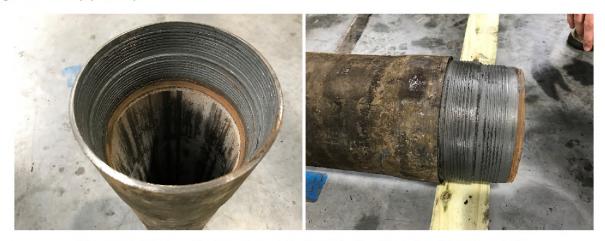
Figure 12: Photos of a 7 in. Speedtite Connection Showing the Box and Pin

Figure 12 shows a connection recovered from the P-34 well in March 2018. The connection OD is slightly larger than the pipe body.

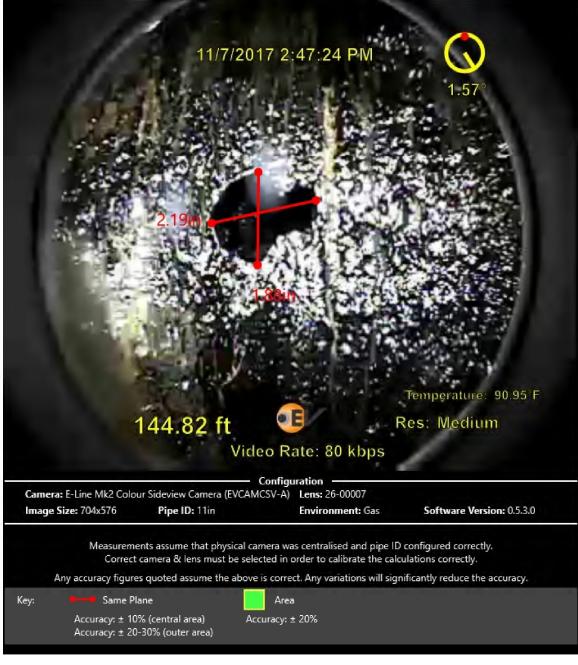
Figure 30: SS-25 Camera Image of a Hole in 11 3/4 in. Casing at Approximately 145 ft WLM

Figure 30 and Figure 31 show camera images of holes in the 11 3/4 in. casing. This camera run was made prior to running a casing scraper. The camera depths have not been correlated so there can be a depth difference compared to the casing inspection log depths.

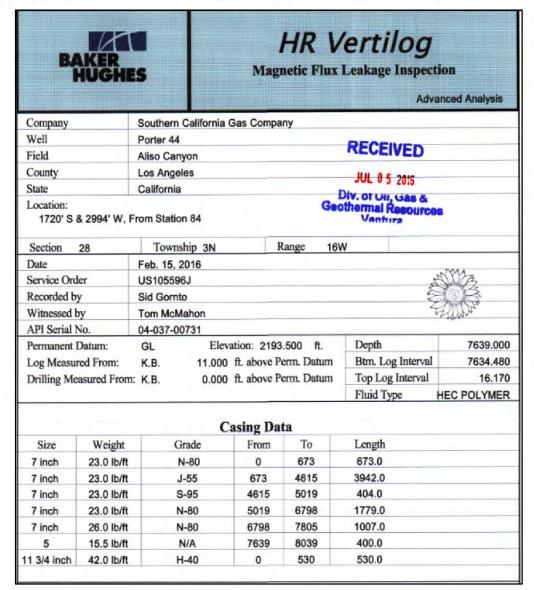
Figure 9: P-44 Vertilog Header

Figure 9 shows the HRVRT log header, and Figure 10 and Figure 11 show the log summary.

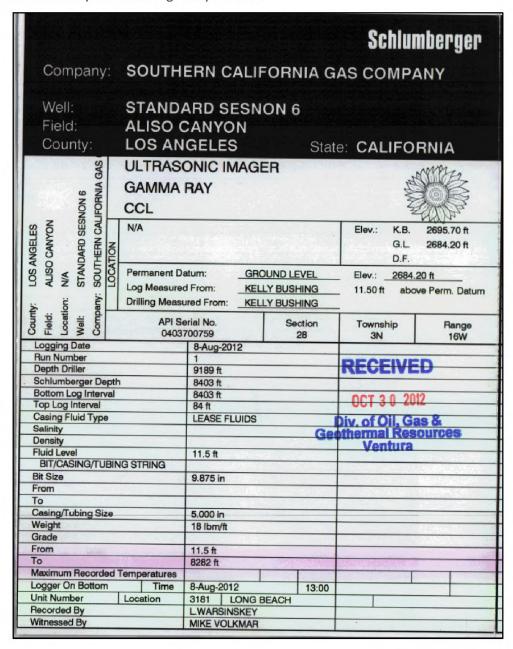
Figure 16: SS-6 USIT Log Header

Figure 16 shows the USIT log header and Figure 17 shows the log legend. Figure 18 shows a section of casing just below surface with the indications down to approximately 160 ft. The log shows abundant quality-control-process-flags from approximately 150 ft to surface indicating some level of aeration in the wellbore fluid which may affect the log interpretation.

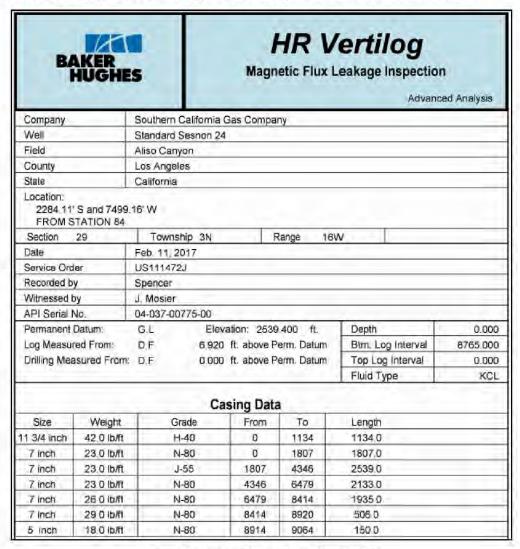
Figure 32: SS-24 HRVRT Log Header [6]

Figure 32 shows the HRVRT header, and Figure 33 and Figure 34 show the log summary.

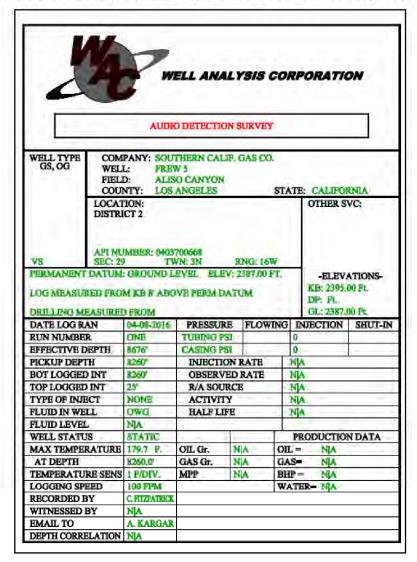
Figure 46: Frew 5 Noise Log Header

Figure 46 shows the noise log header, and Figure 47 and Figure 48 show noise log sections.
