**Exhibits to Prepared Reply Testimony of Robert A. Carnahan, P.E.
(March 20, 2020)**

**VERTILOG®— A DOWN-HOLE CASING INSPECTION
SERVICE**

JOHN N. HAIRE AND JEARALD D. HEFLIN, MEMBERS SPE-AIME, DRESSER ATLAS

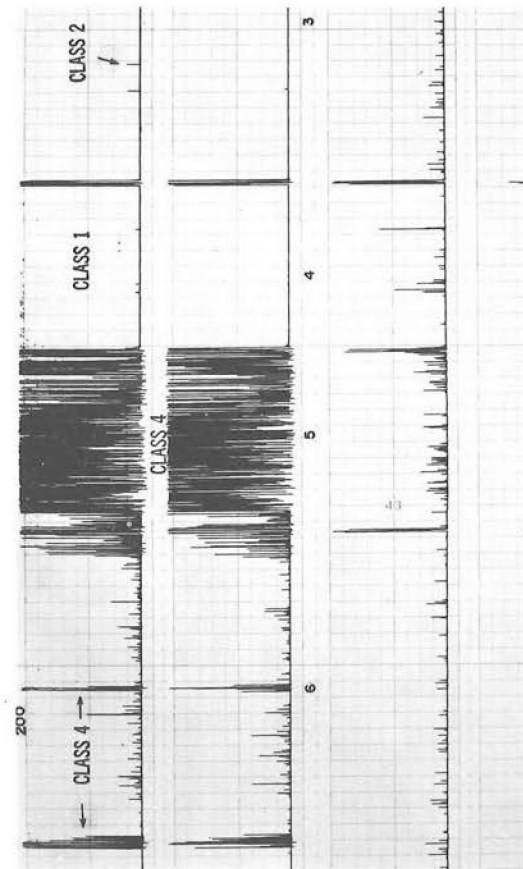
Figure 3 - Severe Casing Damage

Figure 3 is a section of the log from this well illustrating the magnitude of the outside circumferential damage and indicating areas where this has resulted in holes in the casing.

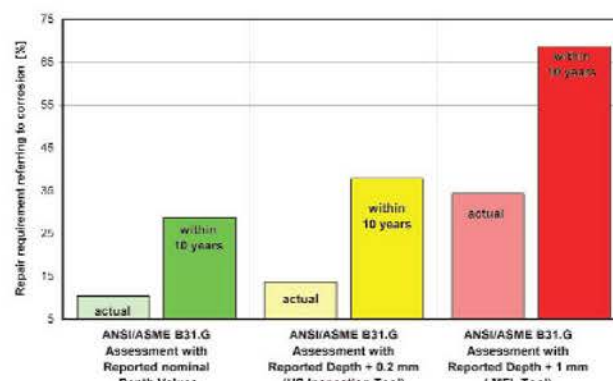
Figure 7: Influence of the degree of accuracy with respect to corrosion depth on actual and long term repair requirement. (Basis: Inspection results of a corroded pipeline)

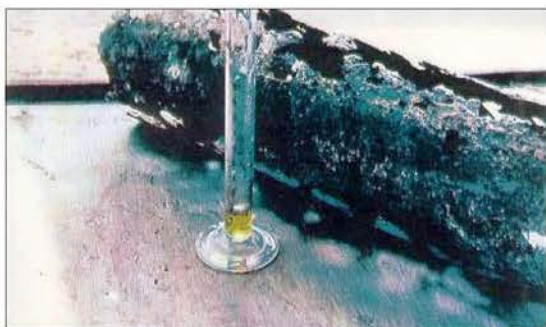
Fig. 15: Piece of WELL-0043 pulled out tubing showing severe damage

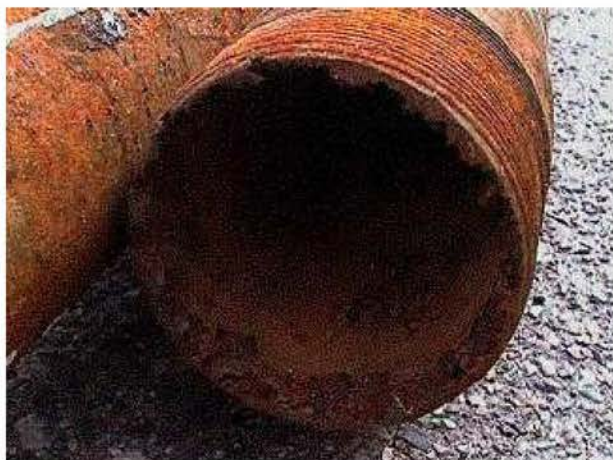
Fig. 17: WELL-0057 Tubing joint pin end

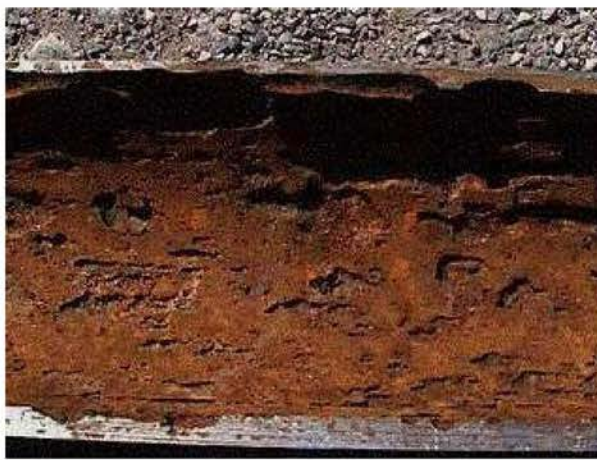
Fig. 18: WELL-0057 Tubing joint box end corroded section

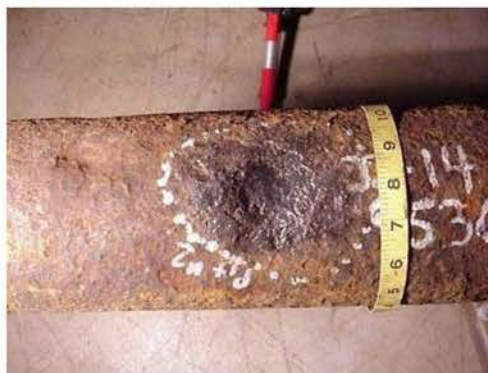
Figure 6 - Digital image showing the defect where Example 1 physical measurements were taken.

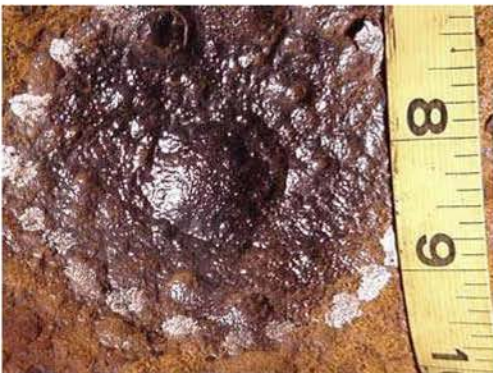
Figure 8 - Digital image showing the defect where Example 2 physical measurements were taken.

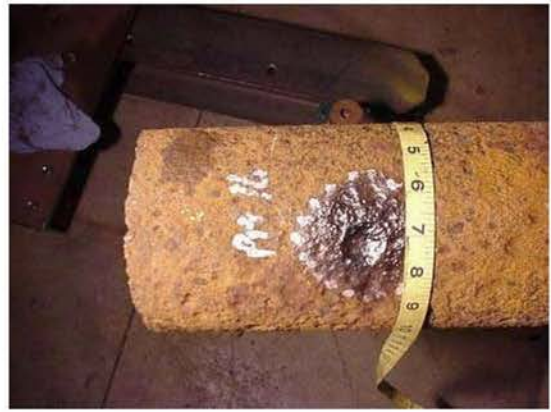
Figure 9 - Digital image showing the defect where Example 2 physical measurements were taken.

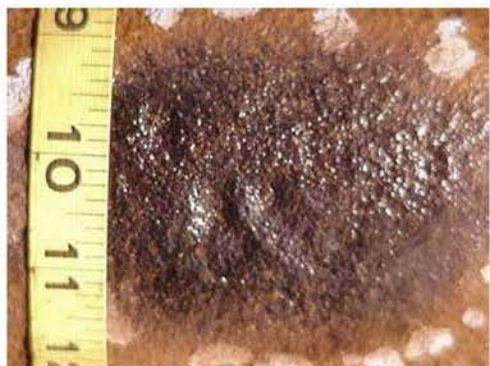
Figure 11 - Digital image showing the defect where Example 3 physical measurements were taken.

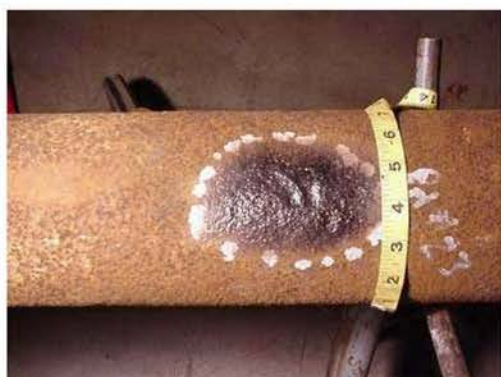
Figure 12 - Digital image showing the defect where Example 3 physical measurements were taken.

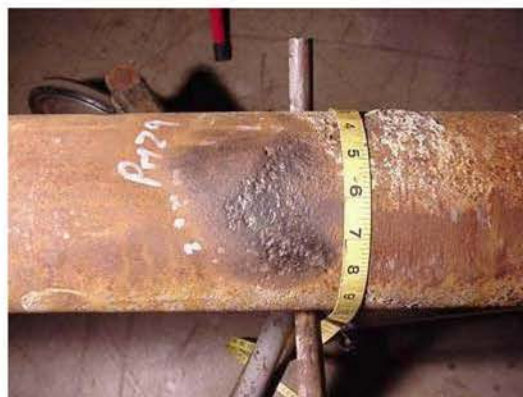
Figure 15 - Digital image showing the defect where Example 4 physical measurements were taken.

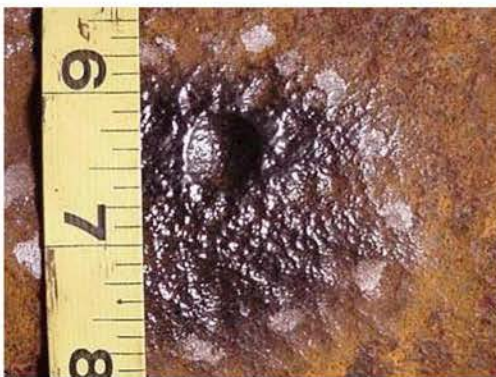
Figure 17 - Digital image showing the defect where Example 5 physical measurements were taken.

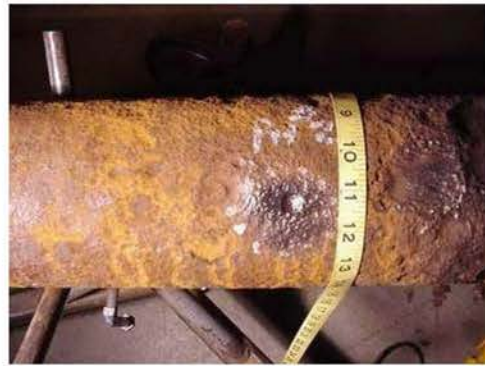
Figure 18 - Digital image showing the defect where Example 5 physical measurements were taken.

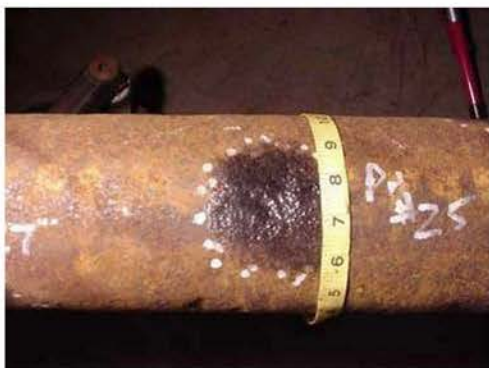
Figure 21 - Digital image showing the defect where Example 6 physical measurements were taken.

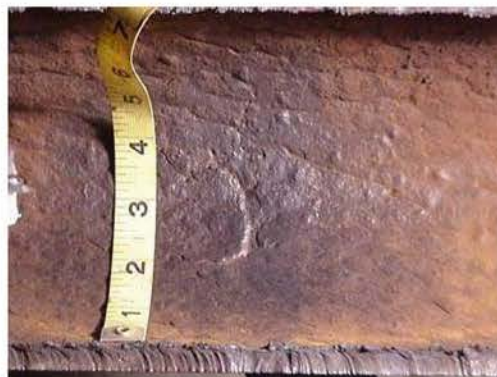
Figure 23 - Digital image showing the defect where Example 7 physical measurements were taken.

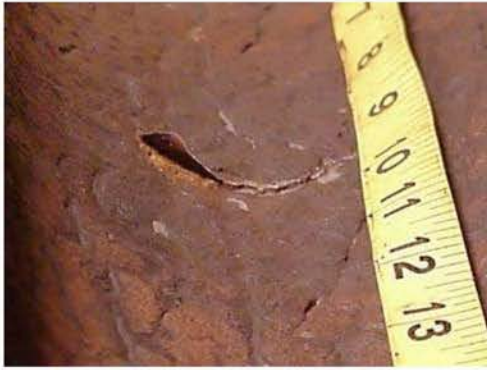
Figure 25 - Digital image showing the defect where Example 7 physical measurements were taken.

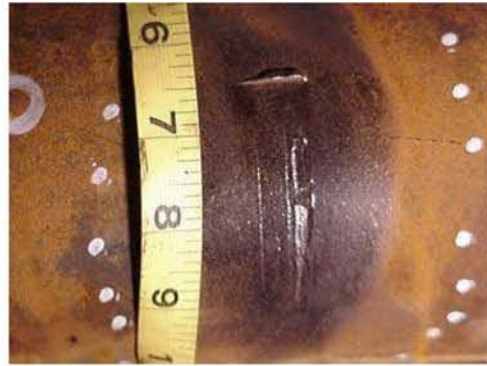
Defect location – external
Defect depth – 0.017 in.
Defect width – 3.0 in.
Defect length – 0.25 in.
% penetration – 5.5%

Figure 27 - Digital image showing the defect where Example 8 physical measurements were taken.

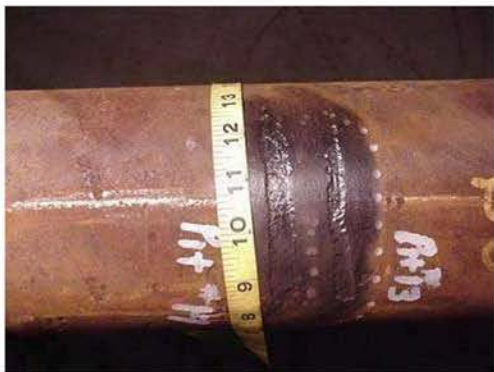
Defect location – external
Defect depth – 0.032 in.
Defect width – 4.0 in.
Defect length – 0.38 in.
% penetration – 10.3%

Figure 29 - Digital image showing the defect where Example 9 physical measurements were taken.
