Description: USI Composite    Format: Log ( LBV1\_USI Corrosion 7inch )    Index Scale: 5 in per 100 ft    Index Unit: ft    Index Type: Measured Depth    Creation Date: 20-Oct-2016 14:28:48

Company: Southern California Gas Company Well: Frew 4  
Composite 1: S008

## SUBSURFACE CASING DEFECT REPORT

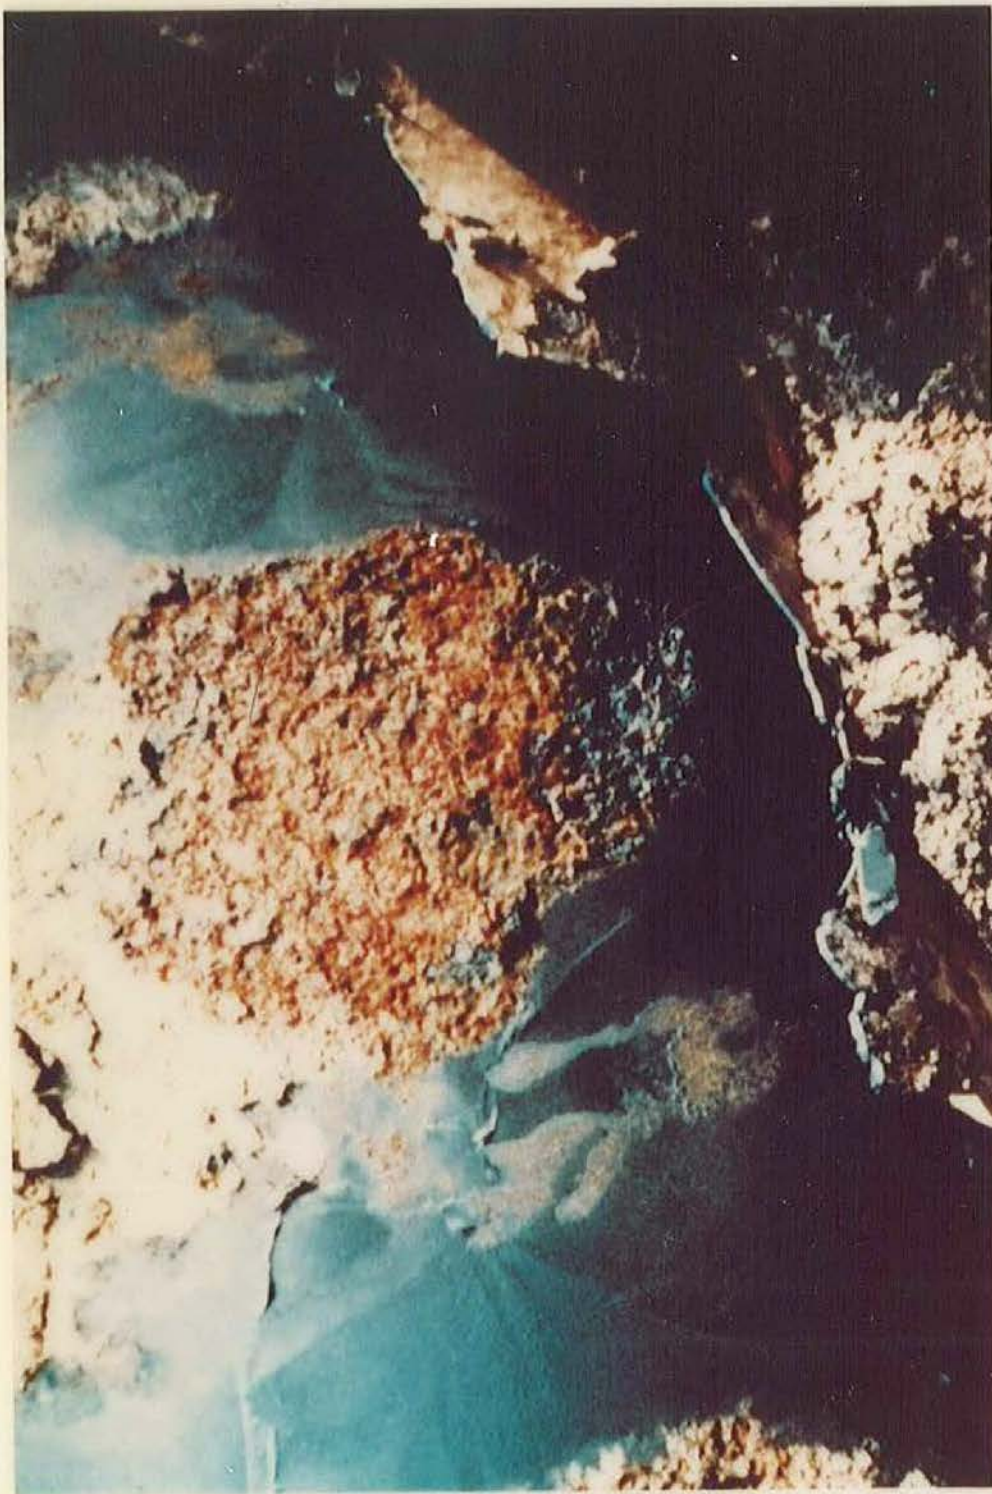
Figure 1. Localized External Corrosion with Deposits, Pits, Craters and Some General Attack

A common type of MIC results in localized attack of carbon steels in the form of pitting, although some general attack takes place as well (see Figure 1). Some cases of severe pitting found under nodules formed at holidays in coatings have been attributed to MIC. Intact coatings may provide some protection against MIC; however, when holidays occur, corrosion often exists under the adjacent disbonded coating (see Figure 2).

Determine whether nodules (discrete "buildup" of deposits) or aggregates of these are present at the corrosion site (see Figures 1, 2, and 11 for examples from field sites). If so, record the information on the GRI Summary Data Sheet (question no. 1). The Site Information Form and the Summary Data Sheet are shown on pages 28 and 29 of this handbook. A supply of these forms accompanies a copy of the field guide. Extra forms are available from Radian Corporation (c/o Jane Wessels), P.O. Box 201088, Austin, Texas 78720-1088 (512/454-4797).

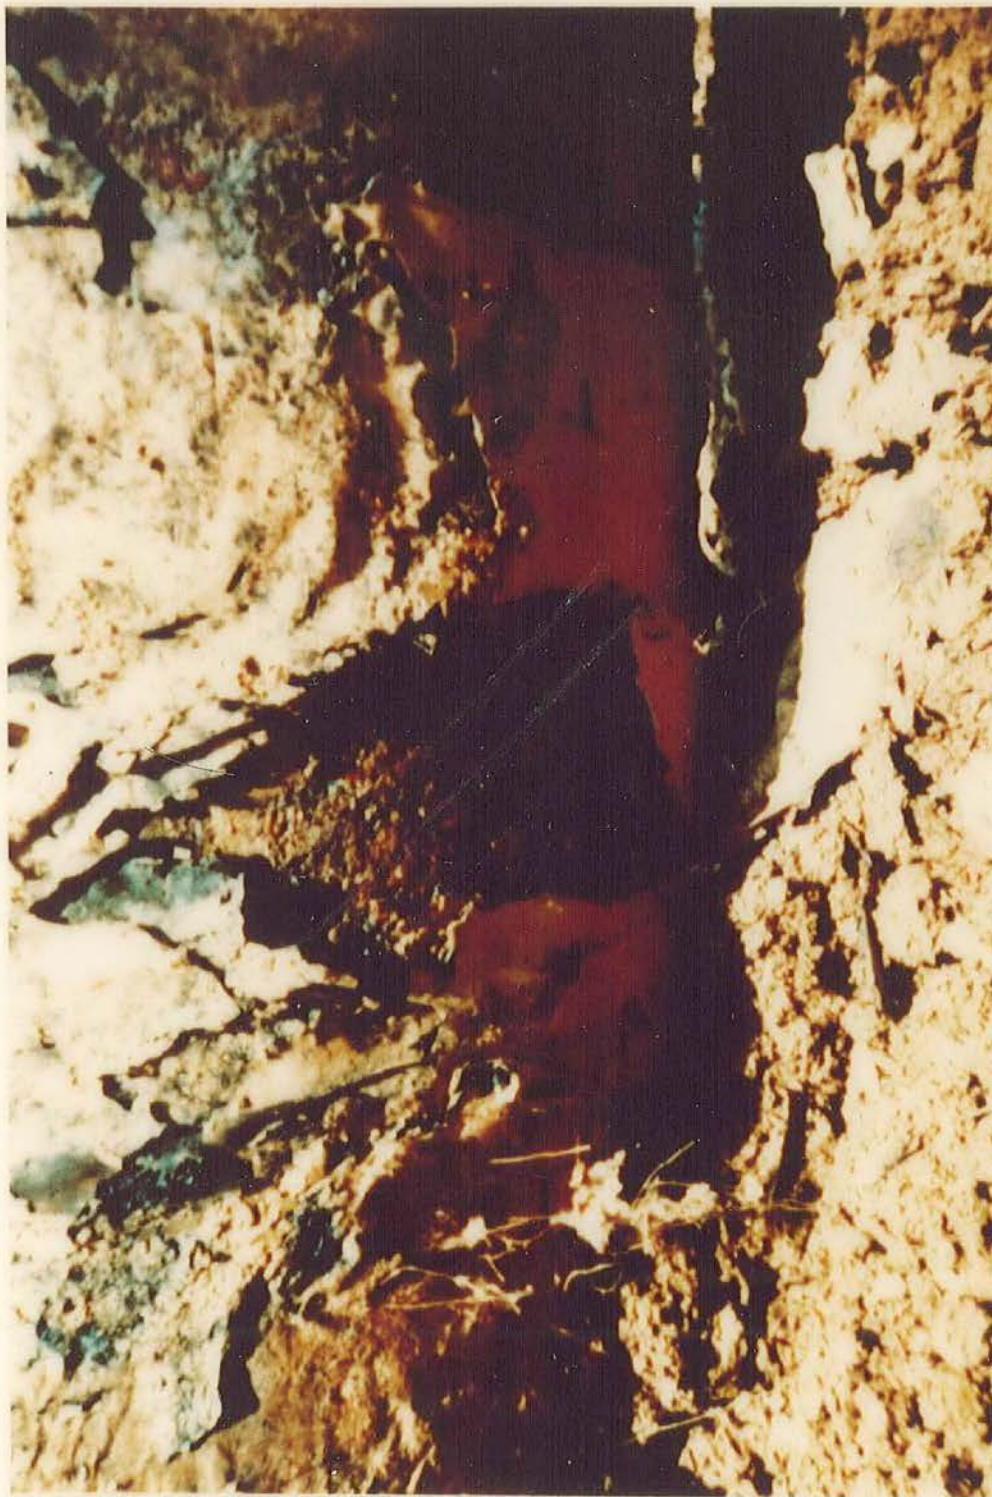
Figure 2. Disbonded Pipeline Coating Associated with Localized External Corrosion

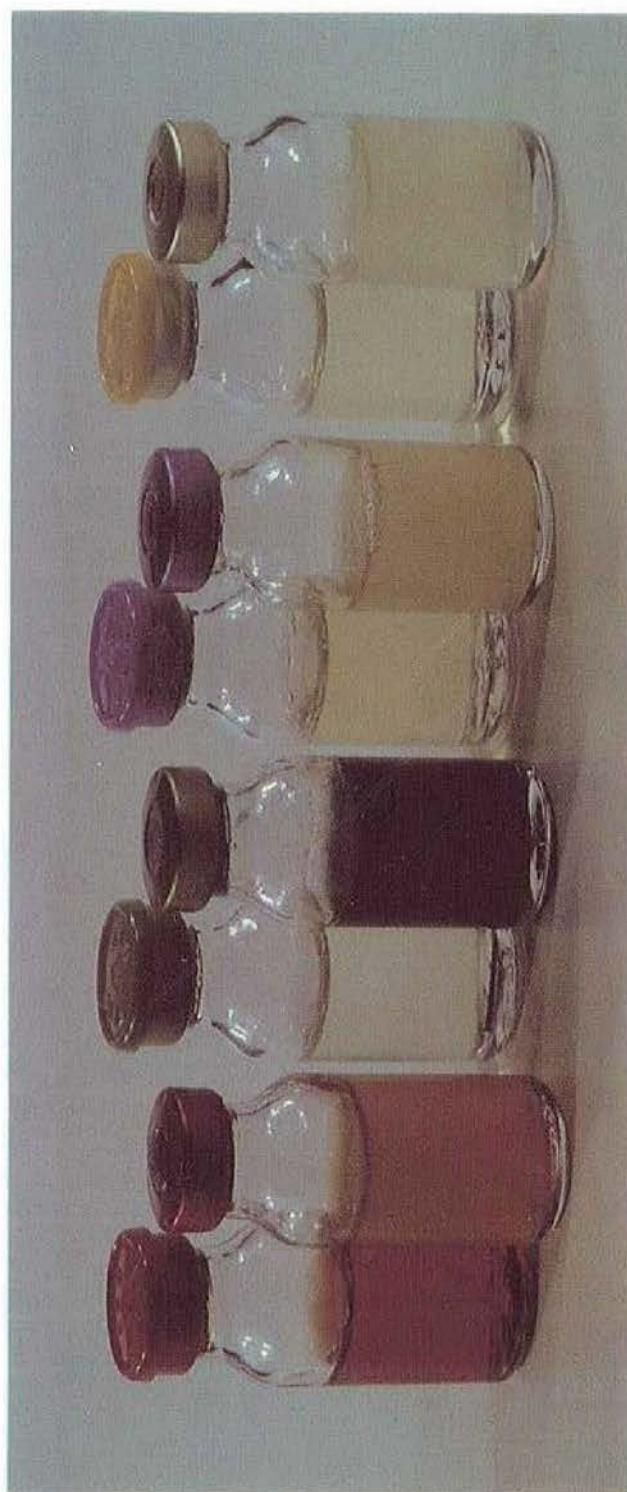
Figure 5. Media Reactions for APB, SRB, Anaerobes and Aerobes

NEGATIVE	YELLOW Positive for APB	NEGATIVE	BLACK Positive for SRB	NEGATIVE	TURBID Positive for ANAEROBES	TURBID Positive for AEROBES
----------	-------------------------------	----------	------------------------------	----------	--	--------------------------------------

After the proper incubation period, interpret the media reactions according to kit directions (see Figures 4 and 5). Record the number of bottles showing positive results for each type media on the Summary Data Sheet (question no. 2). For example, if four turbid MC media bottles and three black SRB media bottles were observed, you would record 4 and 3 on the Summary Data Sheet.

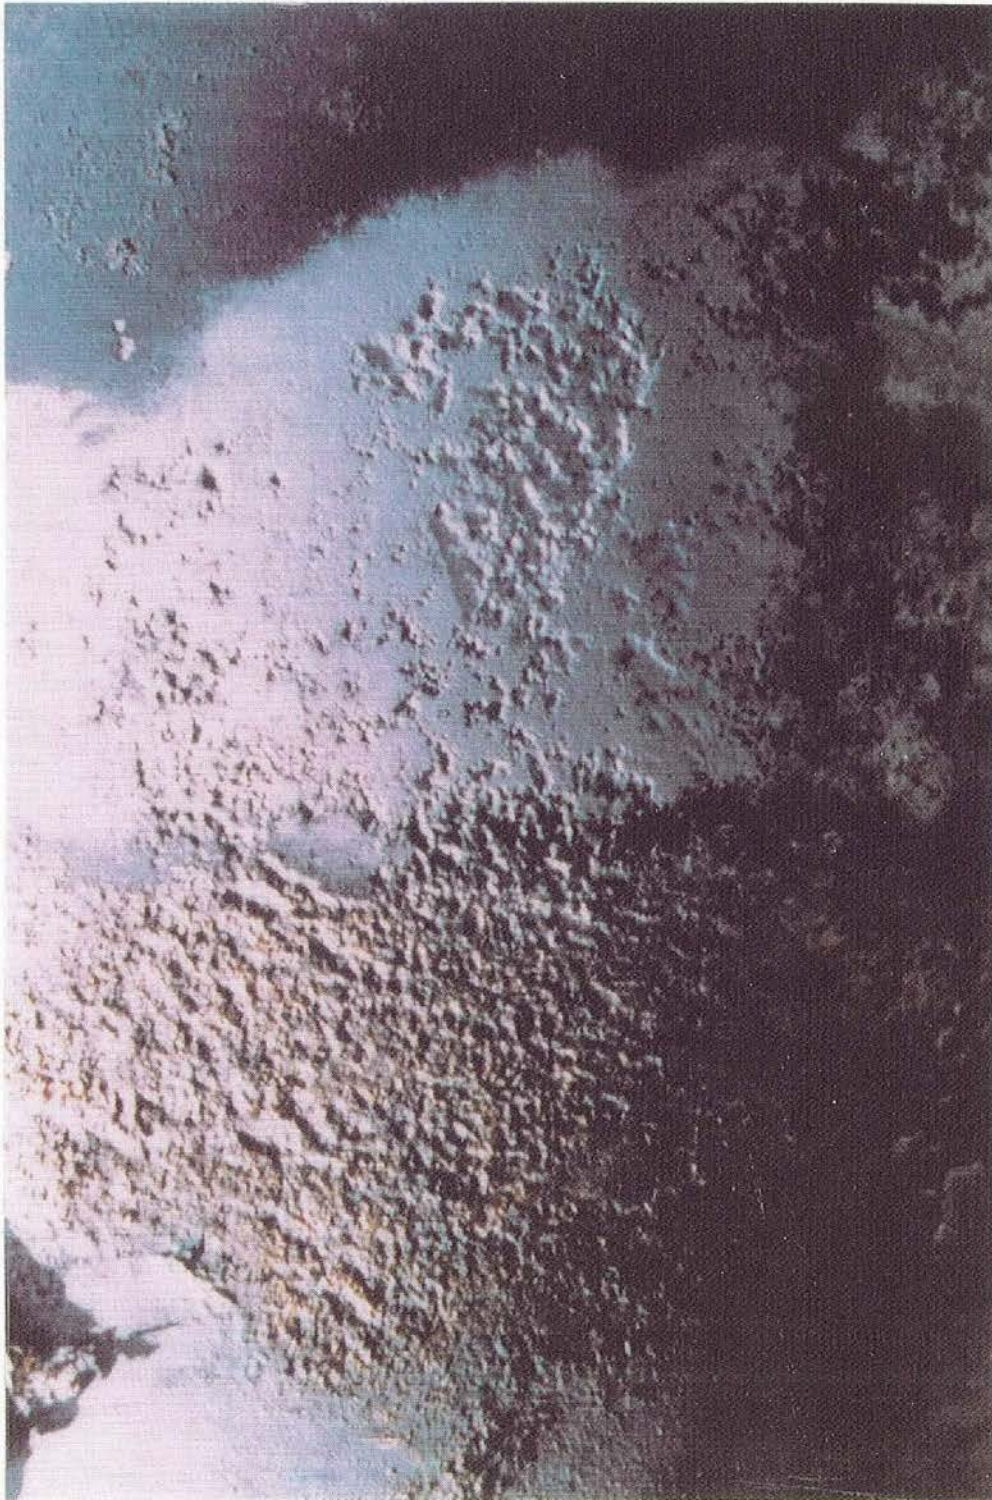
Figure 6. Condition of Pipe After Brush-blast Sandblasting

Refer to Figure 6 for an example of typical surface deposit condition as excavated and after sandblasting.

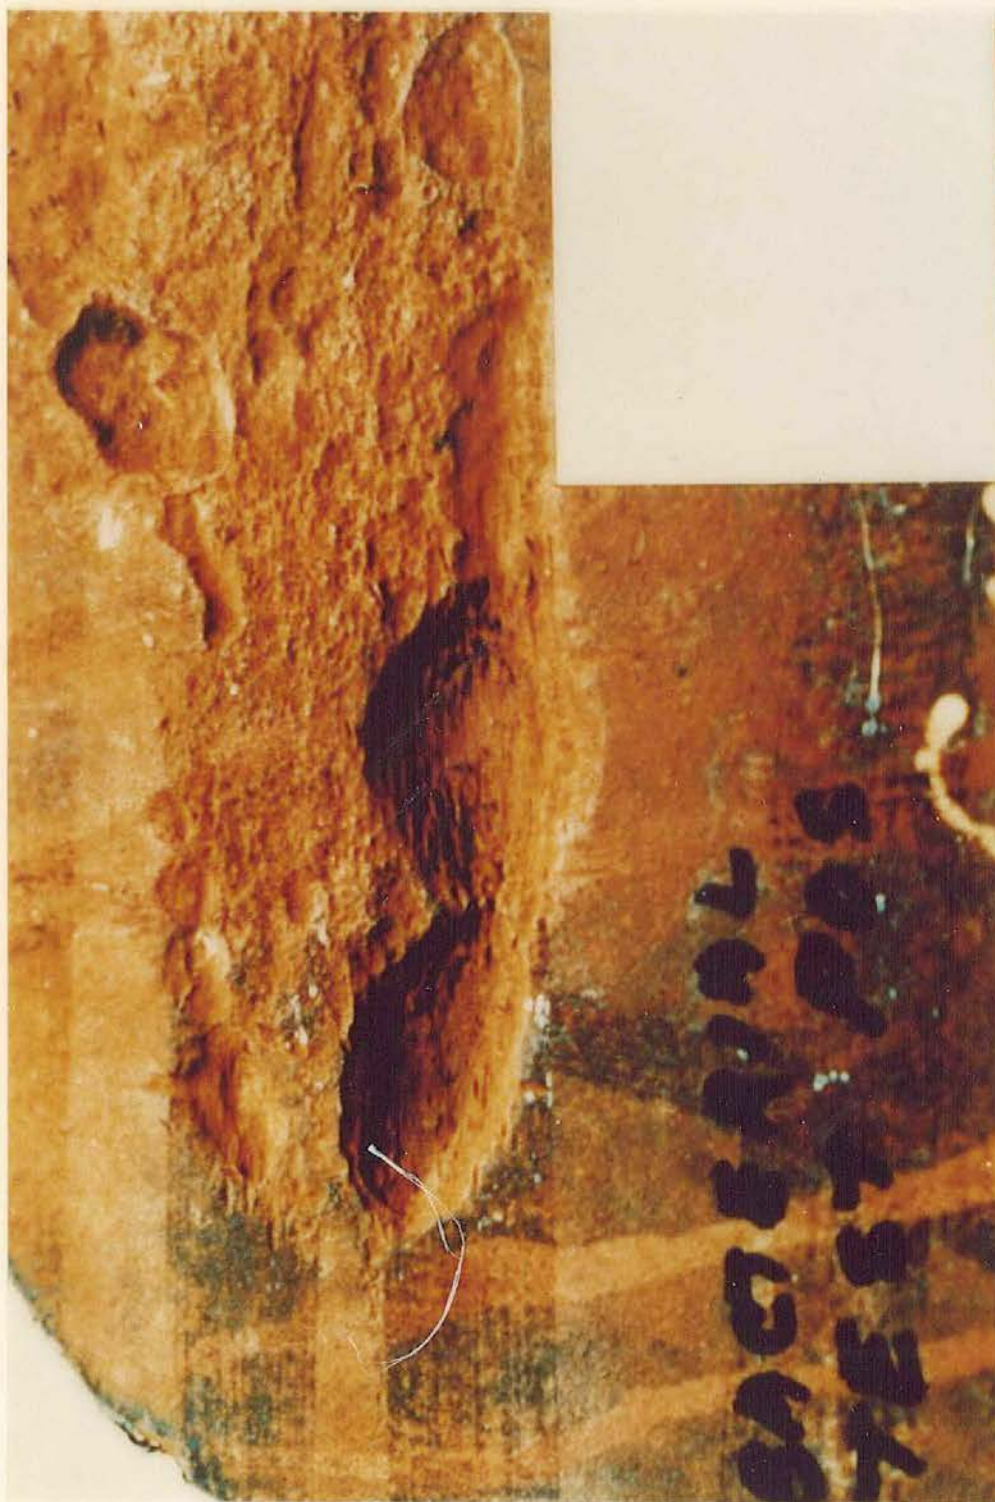
Figure 9. Corrosion Pits with Striations

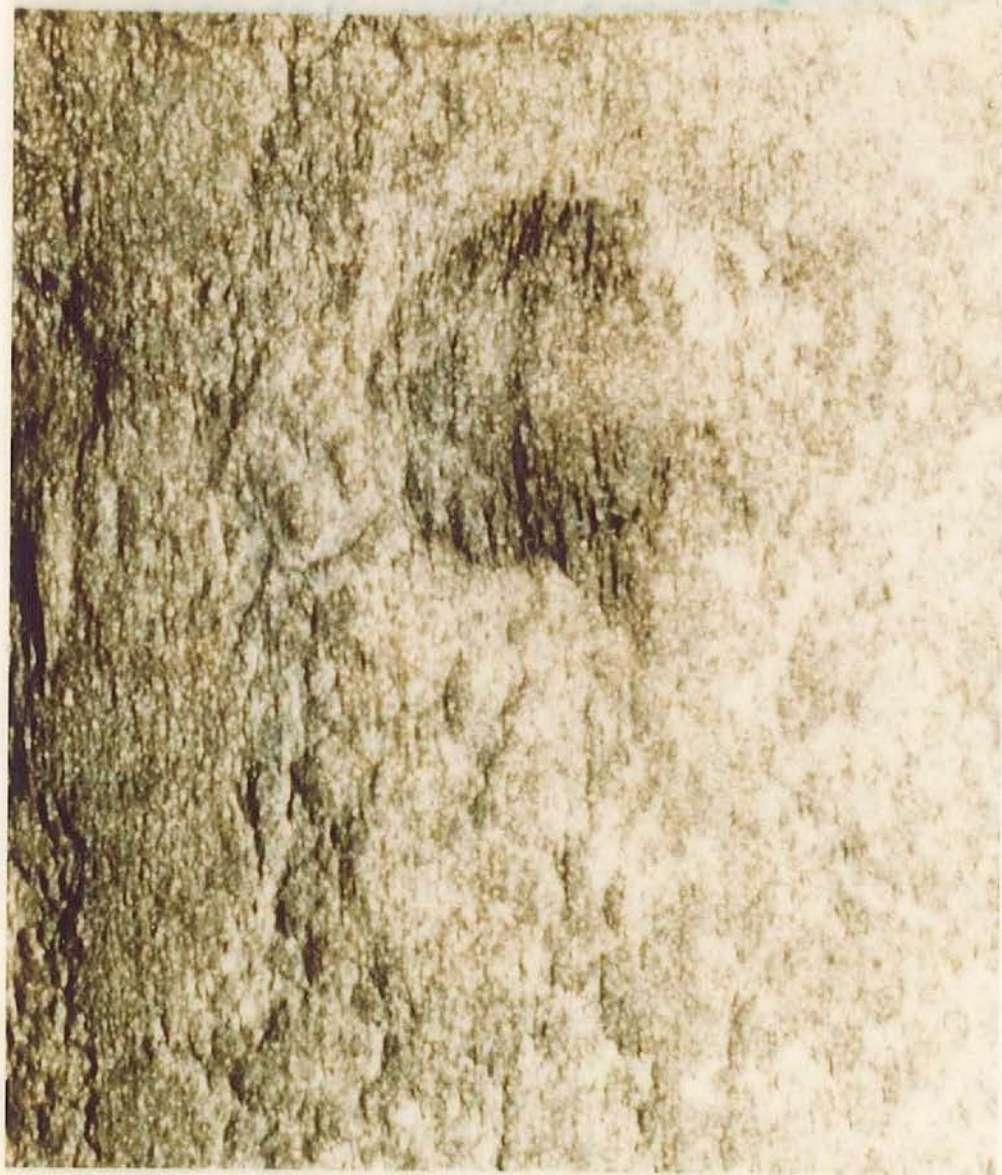
Figure 10. Corrosion Pits with Striations

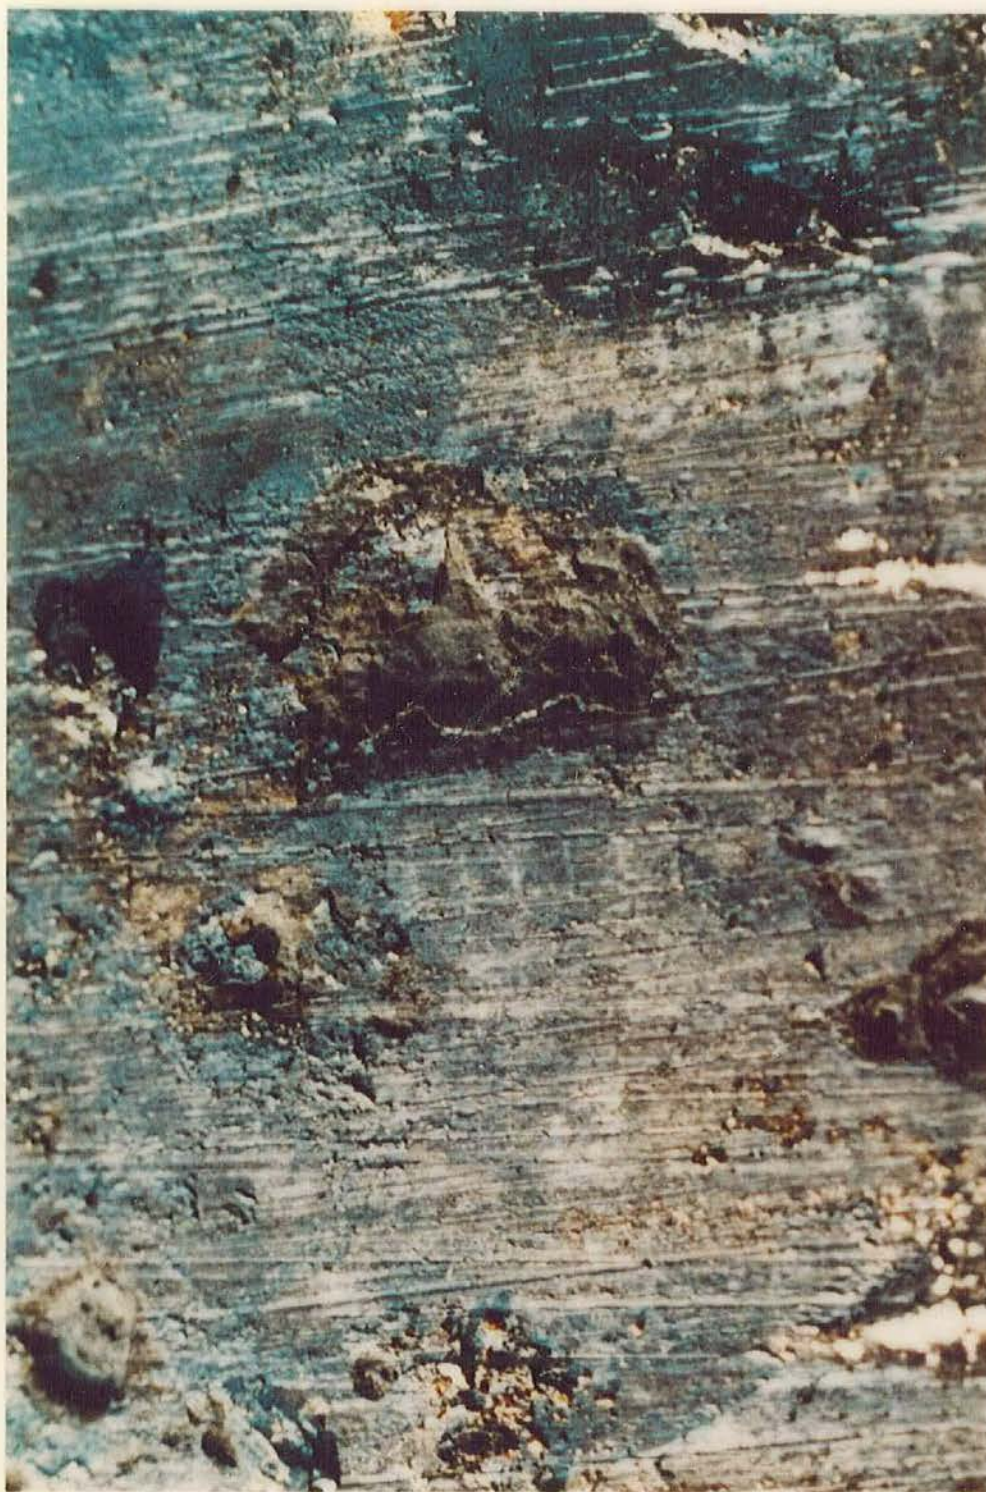
Figure 11. Surface Pit Showing Corrosion Product in Pit

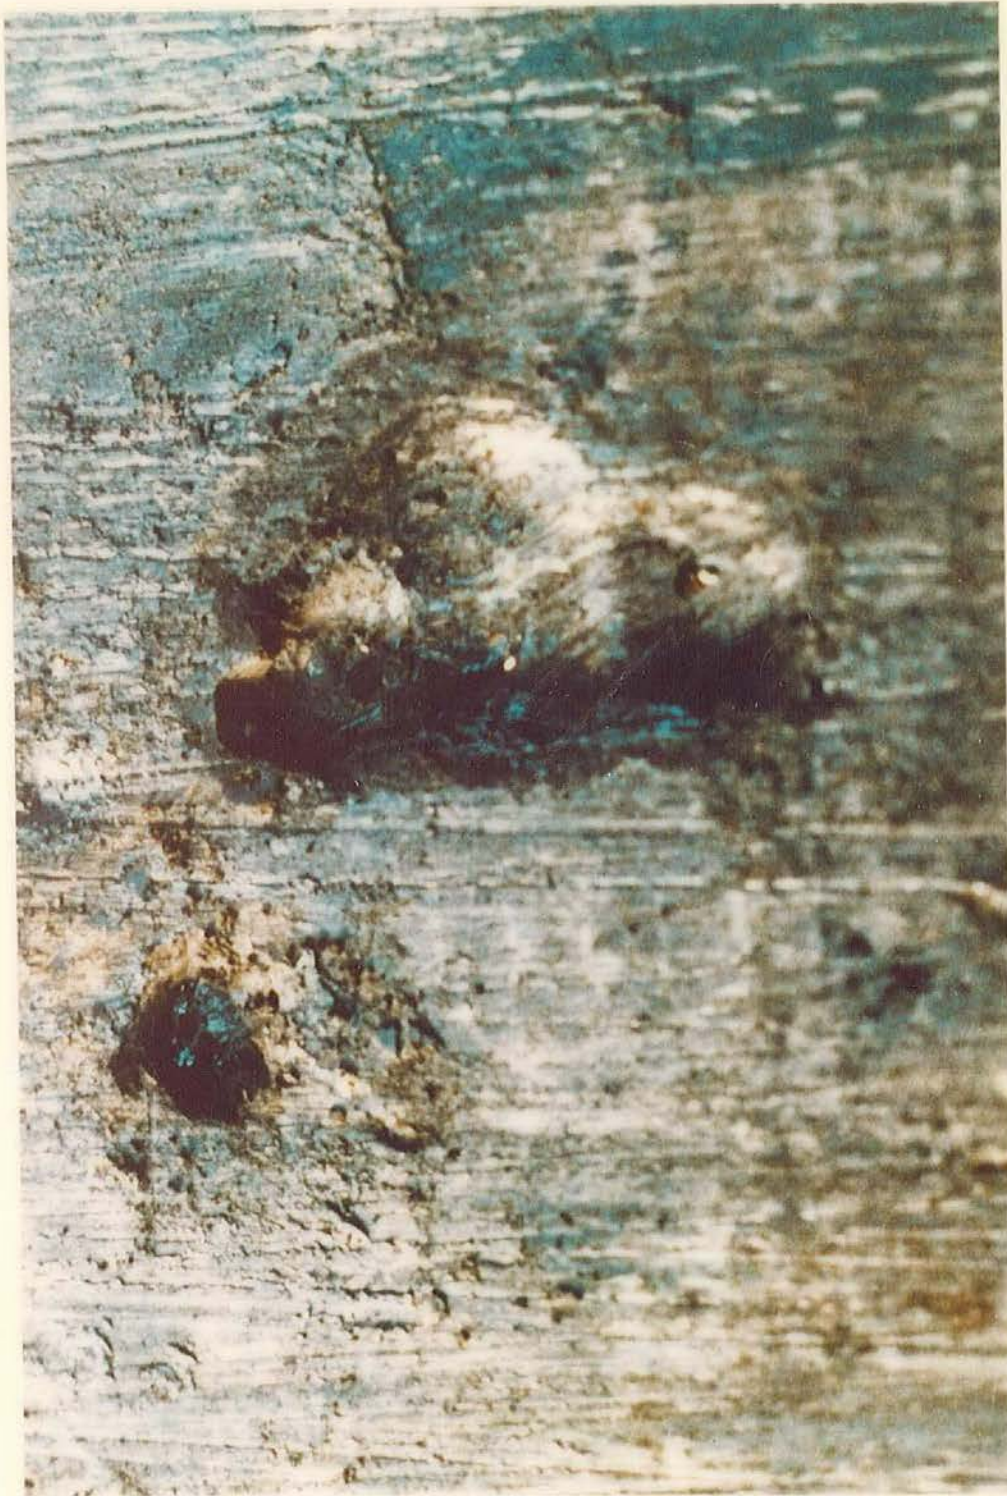
Figure 12. Same Pit After Corrosion Product is Scraped Out

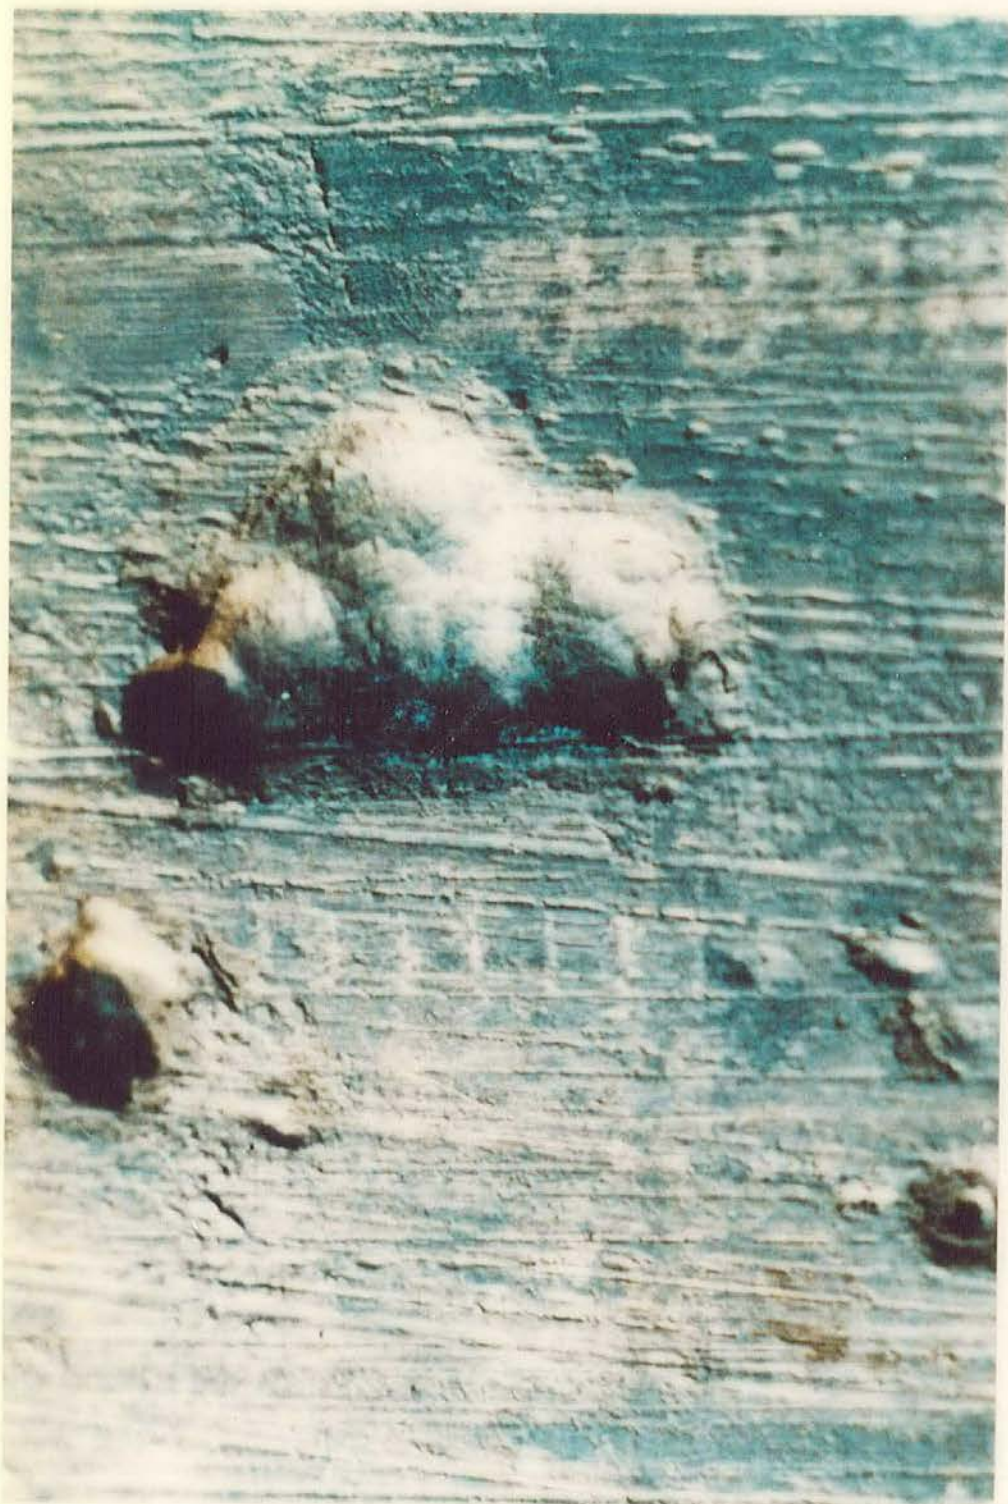
Figure 13 Same Pit After Cleaning with Nylon Brush (Note Cup-like Pits Inside Large Pit)

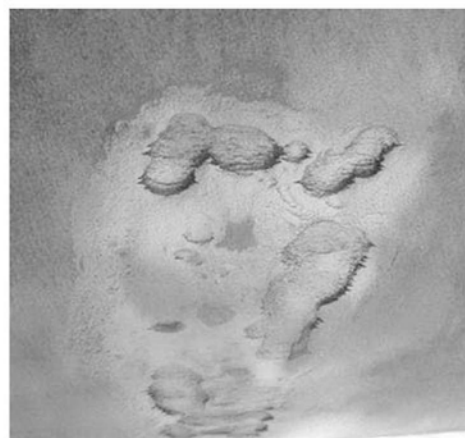
**Fig. 10** Microbially induced corrosion showing striations in the bottom and tunneling into the walls of overlapping pits, as described in Ref 32

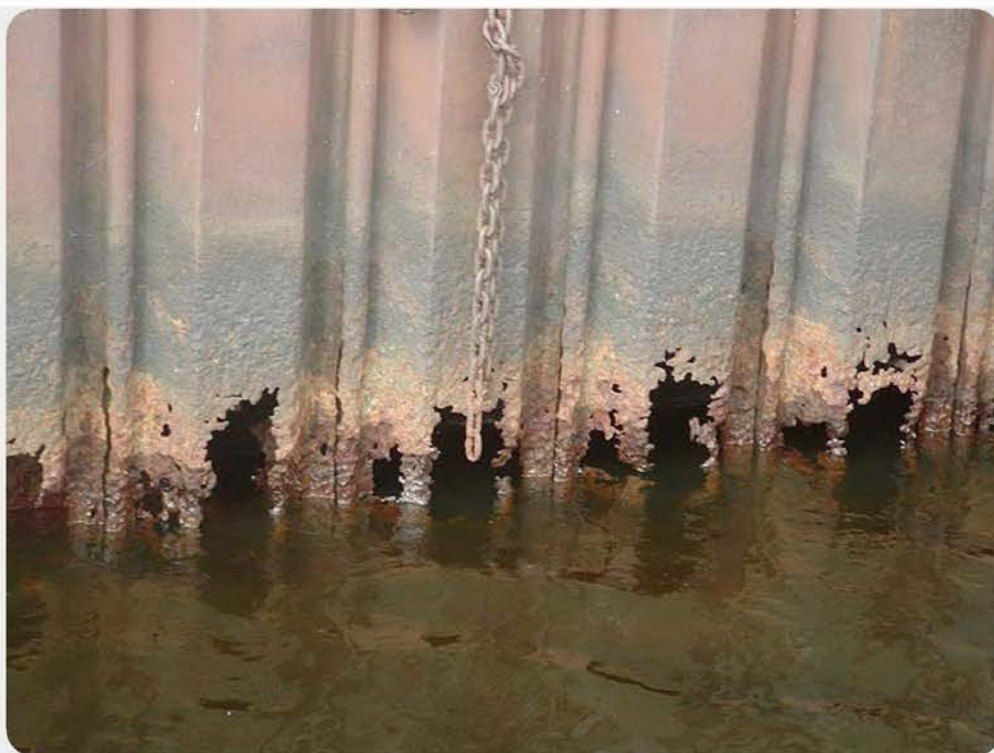
MIC of pilings in the Duluth Superior Harbor in Duluth, Minnesota. Photo courtesy of Gene Clark, University of Wisconsin Sea Grant Institute.
